TR 6.5

CORROSION MONITORING SYSTEMS
INSTALLED IN PORTUGUESE STRUCTURES

PROJECT TITLE: Durable Transport Infrastructure in the Atlantic Area Network

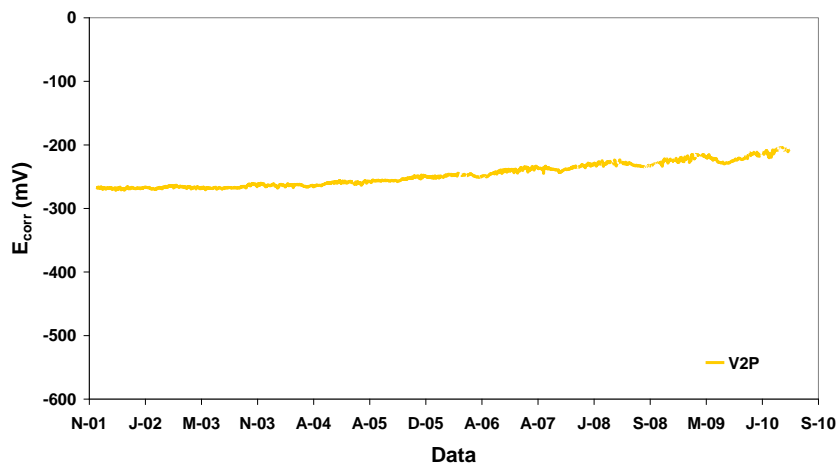
Corrosion potential (Ecorr)

Measurement of Ecorr showed that reinforcement corrosion do not start during the monitoring period.

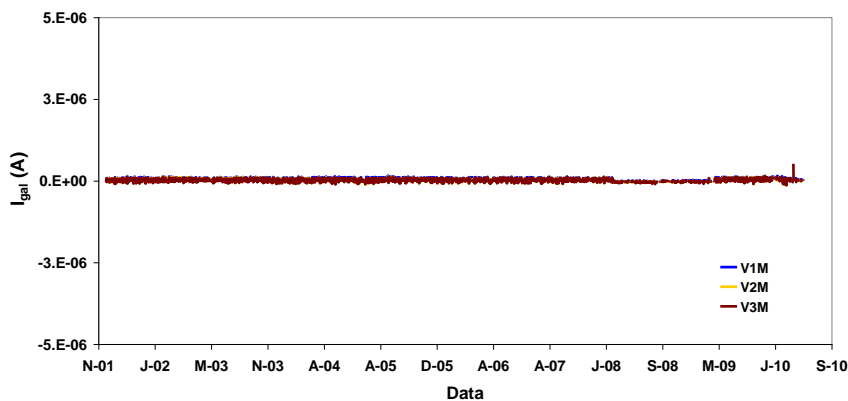
Galvanic Current (I_{gal})

Galvanic currents measured during the monitoring period are low and indicative that the reinforcement is not corroding.

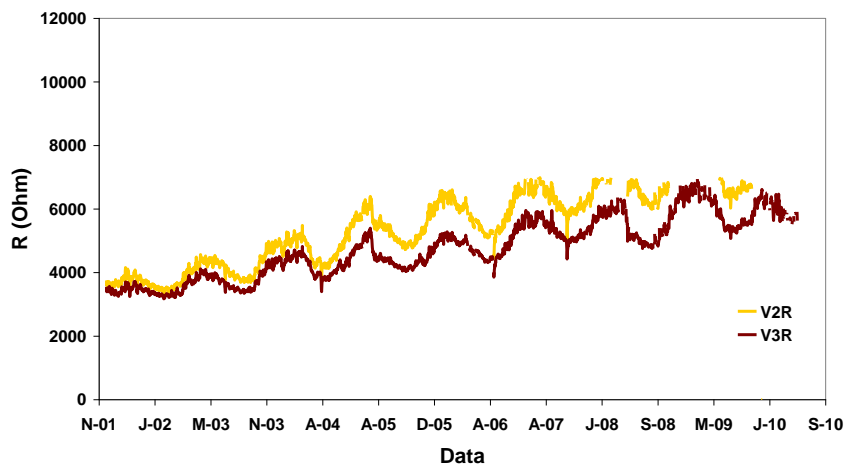
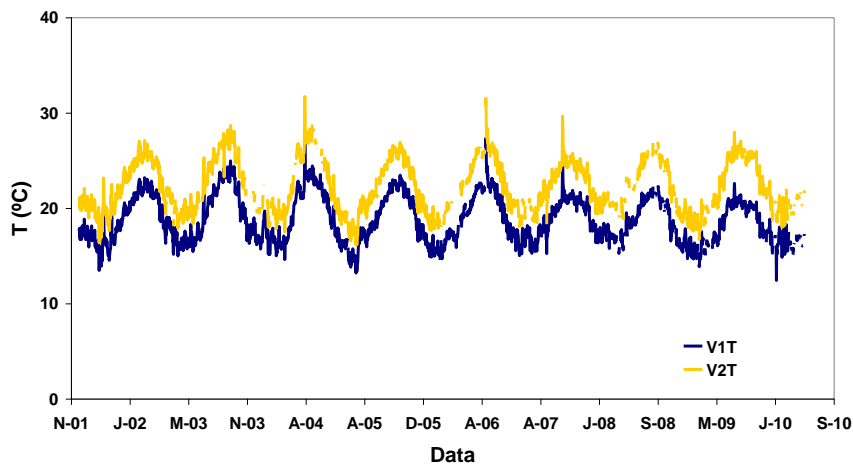
Concrete electrical resistance (R)

No significant changes of R occurred during the monitoring period. R variations have been attributed to the variations of environmental parameters and to the evolution of concrete hydration over time.

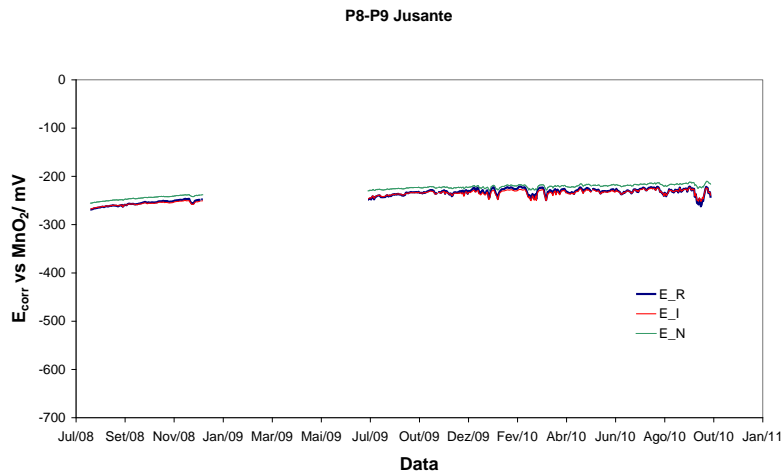
Corrosion potential (E_{corr})

Measurements of E_{corr} showed that reinforcement corrosion do not start during the monitoring period.

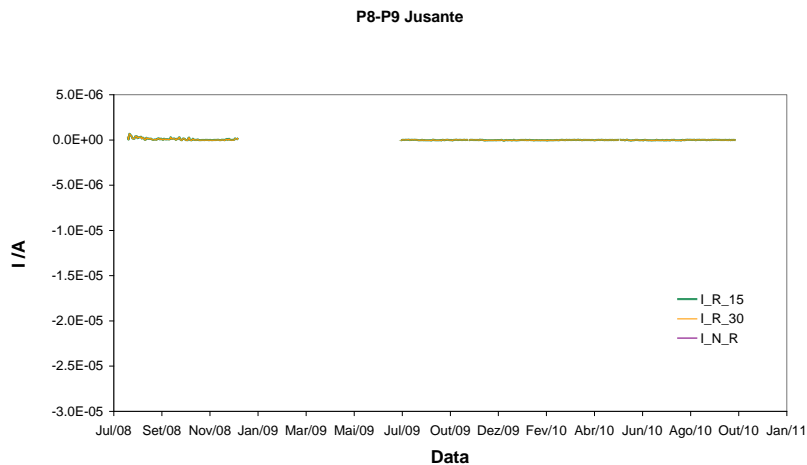
Galvanic Current (I_{gal})

Galvanic currents measured during the monitoring period are low and indicative that the reinforcement is not corroding.

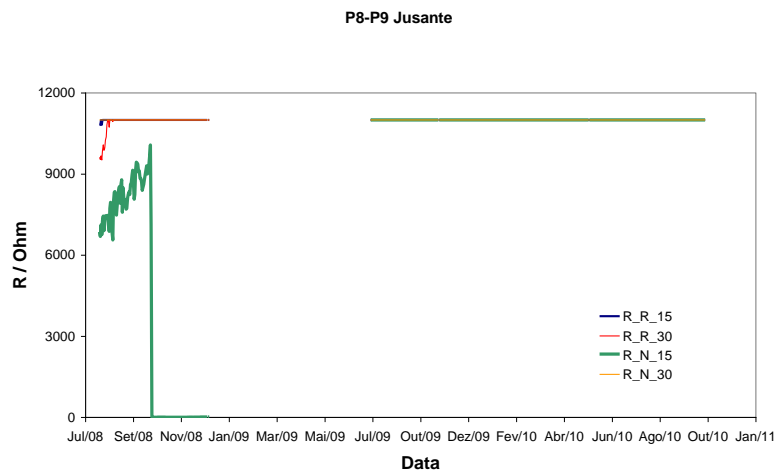
Concrete electrical resistance (R)

In the majority of the instrumented zones no significant changes of R occurred during the monitoring period and R variations have been attributed to the variations of environmental parameters. However in some places a sharp decrease of R values was detected and attributed to the formation of cracks in the concrete cover.

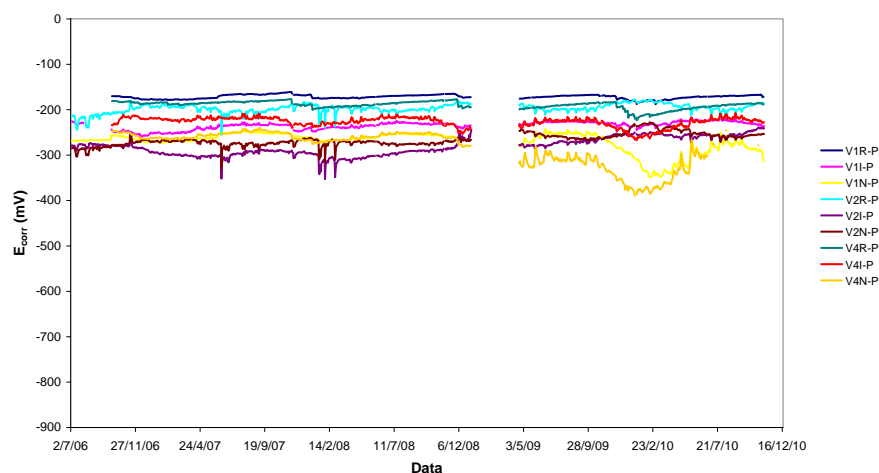
Corrosion potential (E_{corr})

Measurement of E_{corr} showed that reinforcement corrosion do not re-start during the monitoring period.

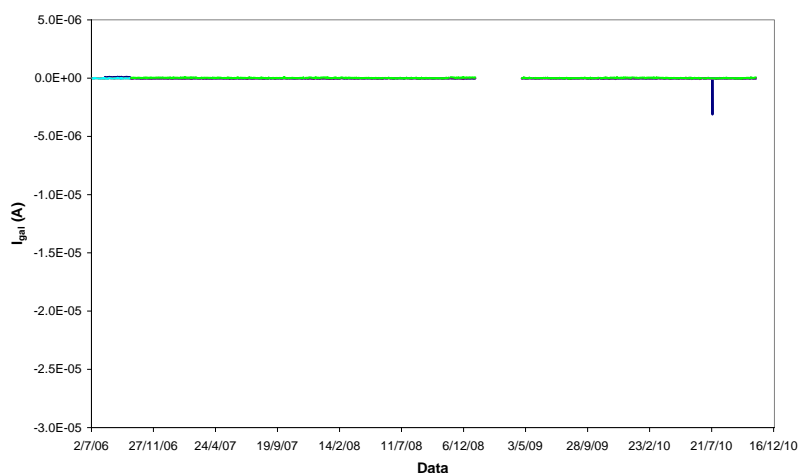
Galvanic Current (I_{gal})

Galvanic currents measured during the monitoring period present low values, indicative that the reinforcement is not corroding.

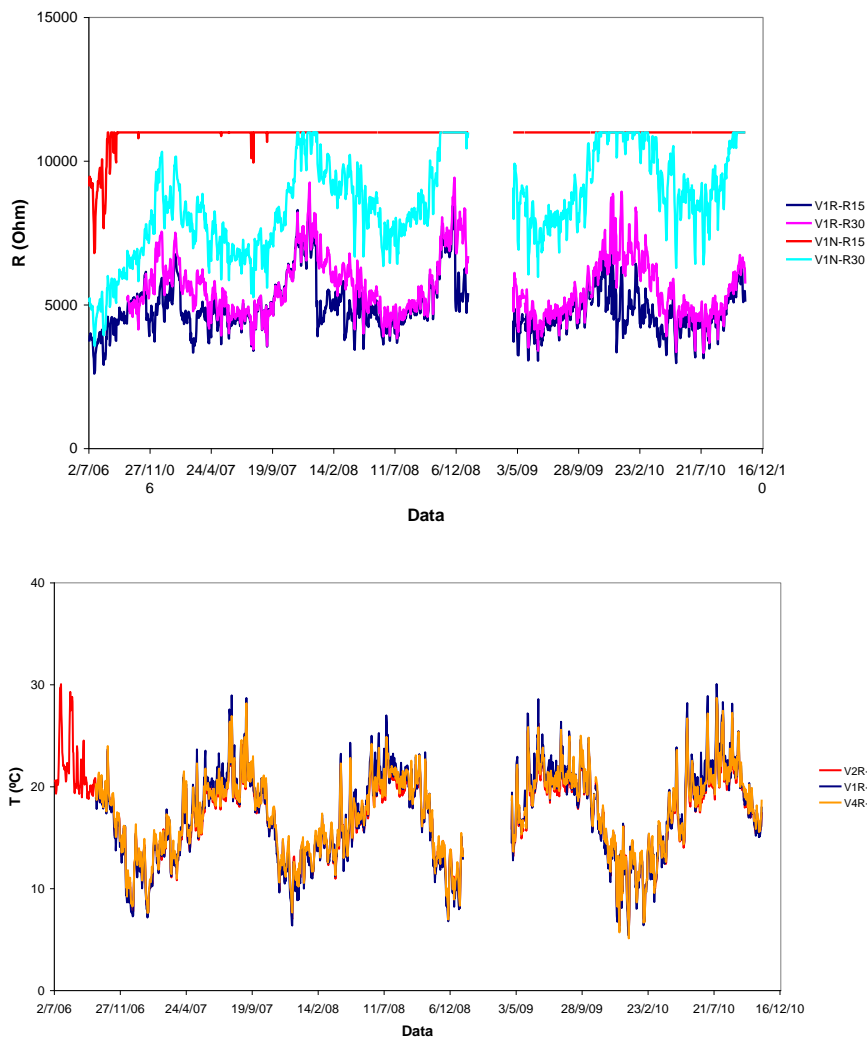
Repaired areas

No significant changes of R occurred during the monitoring period. R cyclic variations have been attributed to the variations of environmental parameters, namely temperature, like it can be seen by comparing of the two next figures.

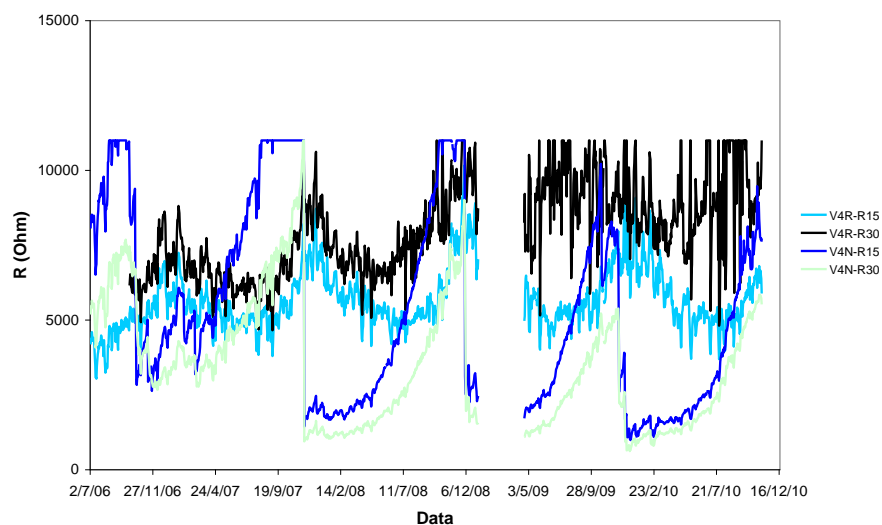
No repaired areas

Very low R values are measured in one area at 15 and 30 cm of concrete cover (V4N-R-15 and V4N-R30). The values decrease rapidly in certain periods what is consistent with the occurrence of rain followed by a drying period. This behaviour, probably due to cracking, showed that, in this local, the reinforcement is not adequately protected against corrosion.

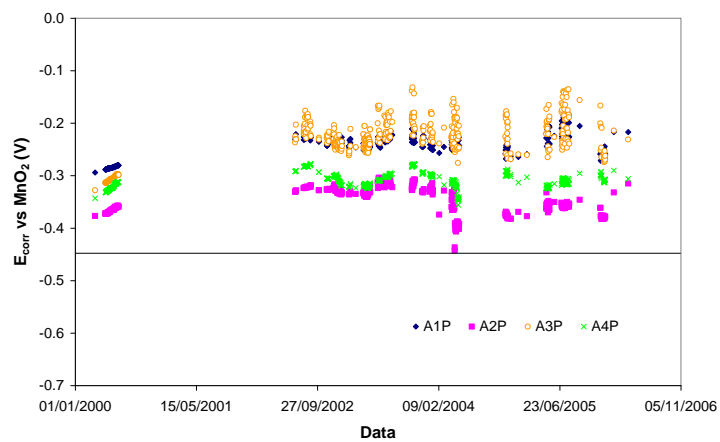
Corrosion potential (E_{corr})

Measurement of E_{corr} showed that reinforcement corrosion do not start during the monitoring period.

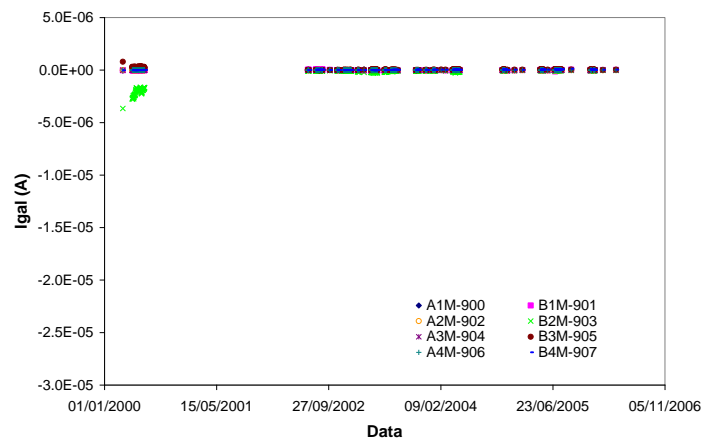
Galvanic Current (I_{gal})

Galvanic currents measured during the monitoring period are low and indicative that the reinforcement is not corroding.

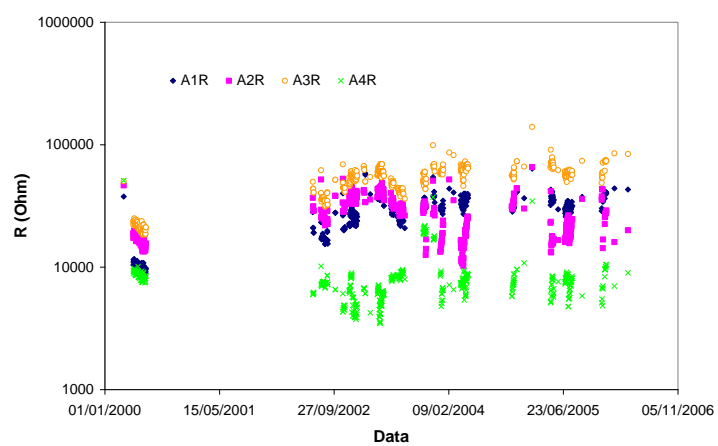
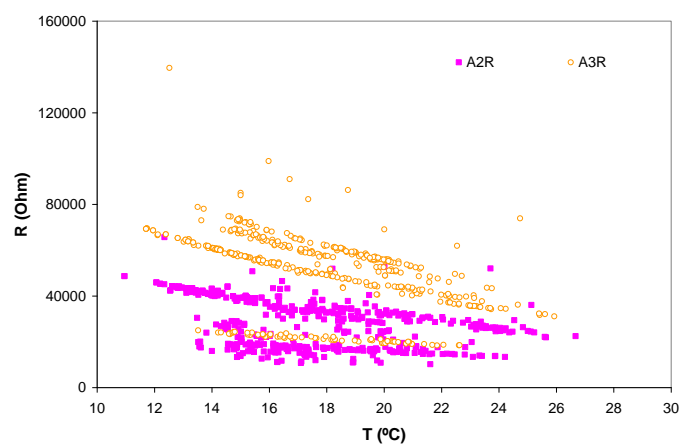
Concrete electrical resistance (R)

No significant changes of R occurred during the monitoring period. R variations have been attributed to the variations of environmental parameters
