REPAIR SYSTEMS IN STRUCTURES

PRACTICAL CASES

TR 7.1  
**REPAIR SYSTEMS IN STRUCTURES - PRACTICAL  
CASES**

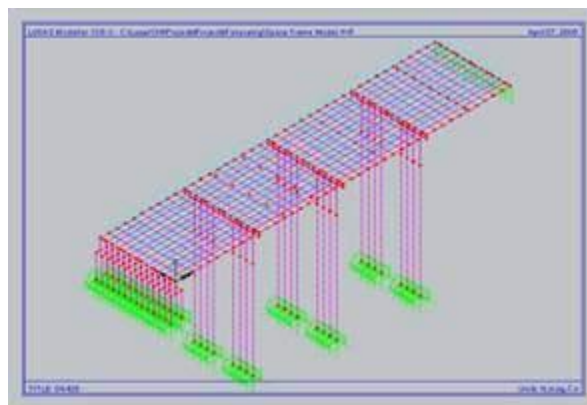
Figure 12. FE Model of structure

For deterministic assessment the structure was modelled as a 3-dimensionsal space frame model as illustrated in Figure 12. This model was used for two purposes: (a) the calculation of ultimate load effects for superimposed dead and live loads in order to determine the ultimate load effects on the structure and (b) the calculation of the serviceability and working load effects for superimposed dead loads, live loads, creep and shrinkage, temperature and differential settlement. The latter was used to develop an understanding of the possible reasons for development of cracking observed at the pier crossheads and at the top of the deck over the pier diaphragms.

The results of the serviceability limit state checks indicated the level of overstress at the top of the in-situ concrete was an issue and the concrete would crack at this location under HA and HB loading.

In order to investigate the transverse cracks in the pier crosshead a transverse stress analysis was conducted. It was found that in the transverse direction two groups of four piles create a significant restraint to the shrinkage of the in-situ concrete. Further assessment of the pier diaphragms indicated that there was a significant shortfall in the reinforcement provided to resist the induced shrinkage strains. The analysis demonstrated that the ULS torsion moments (under HA and HB loading) exceeded the torsion capacity of the pier diaphragm. The torsion capacity of the diaphragm may also have been exceeded during construction, depending on the construction sequence.

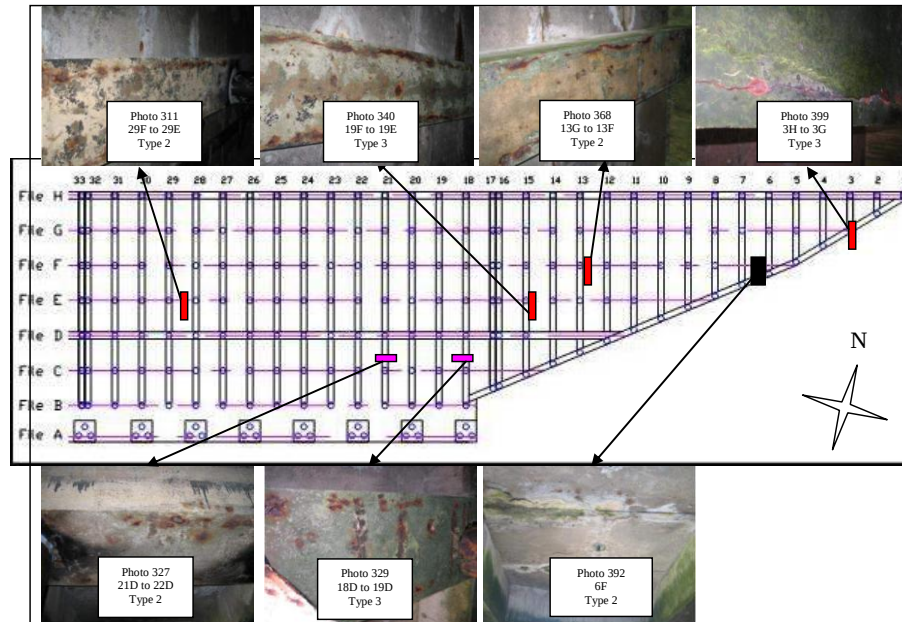
Fig.13. Photo reporting visual inspection

| Location | Photo | Comment | degradation type |
|---|---|---|---|
| 17D/18D | | Cracking and corrosion stains in angles | 2 |
| 18D/19D | 329 | Apparent steel + concrete expansion + corrosion craking | 3 |
| 27D/28D | 320 | Concrete delamination + Corrosion stains in angles + corrosion craking | 3 |

| 30D/31D | | Concrete delamination + Corrosion stains in angles + corrosion cracking | 3 |

Photos are reported on the structures as shown in figure 13 to determine chloride profile localisation. The profiles were done for the three degradation types.

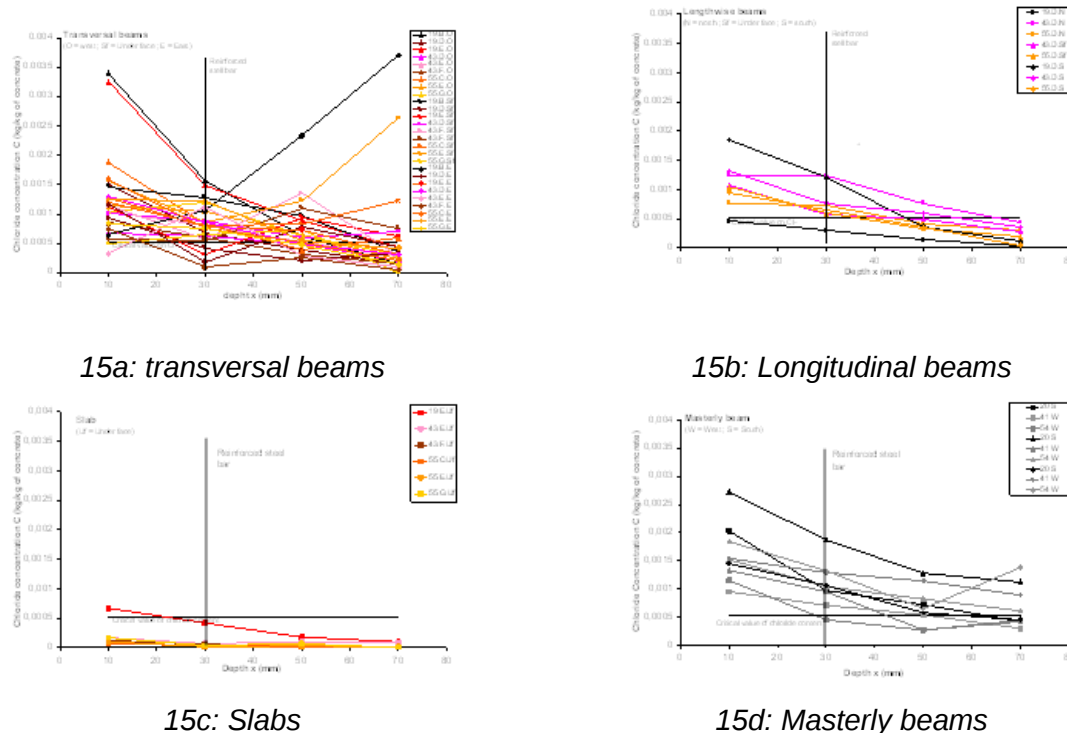
Fig.15. Total chloride profile

The chloride profiles are similar for longitudinal transversal and masterly beams. Only slab have low chloride content which agrees with the visual inspection: no corrosion stain were detected. These slabs are less exposed to sea water because these are higher.

By comparing these profiles with the critical chloride concentration value and the position of the first reinforcement (3 cm), it is obvious that almost all steel bars present a strong risk of corrosion, even if this is not visible on the beams surface. Let us recall that corrosion is supposed to start for concrete reinforcement when the chloride concentration reaches 0.00052 kg/kg of concrete (value suggested by European rule EN 206: 0.4% of chloride ions by cement weight (NF EN 206-1)).

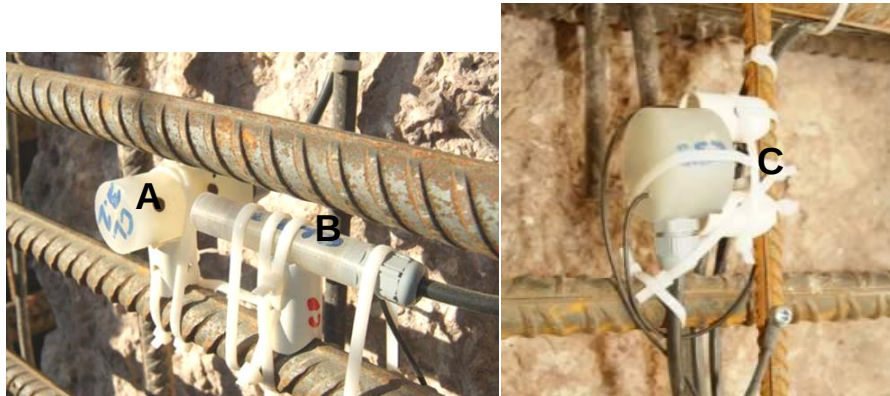
*Fig. 19. Chloride and corrosion probes*

These were secured to the retrofitted crosshead reinforcement cage. In total ten probes were embedded in each crosshead. The southern and northern faces of the crossheads were each instrumented with one chloride ion penetration depth probe, two corrosion potential probes and one corrosion rate probe. The eastern, or seaward, end of the crosshead beams were instrumented with a chloride ion penetration depth probe and a corrosion potential probe. The undersides and western end of the crosshead beams were not instrumented. Temperature and humidity sensors were installed on the eastern face of crosshead 2, the eastern face of crosshead 5 and the western side of the South abutment. Figure 19 shows the three different types of corrosion probes attached to the retrofitted reinforcement cage

before the repair concrete was placed. In the figure the chloride-ion penetration depth probe is labelled A, the corrosion potential probe is labelled B, and the corrosion rate probe is labelled C.

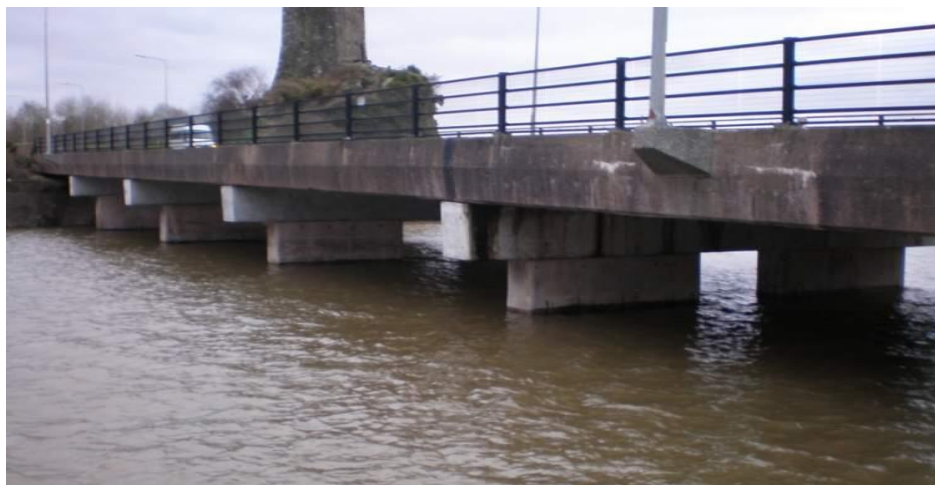
*Fig. 20. Photograph of effects of failed expansion joint*

A visual inspection of Ferrycarrig Bridge was carried out in on the 19th of January 2010. The bridge repairs were found to be performing well with the exception of the expansion joint. It was found that the expansion joint had failed just two years after construction. The precise cause of the failure has yet to be discovered. The effect of the failed expansion joint can be seen below in Figure 18. The expansion joint is located above the central support, the support closest to the camera. The water staining on this crosshead beam can clearly be seen. The initial steps to solve the problem are currently been taken.
