Strategies for Durability. The view of the Road Authority of Galicia

January 21st, 2011

2. THE EXPERIENCE OF THE AROSA ISLAND BRIDGE

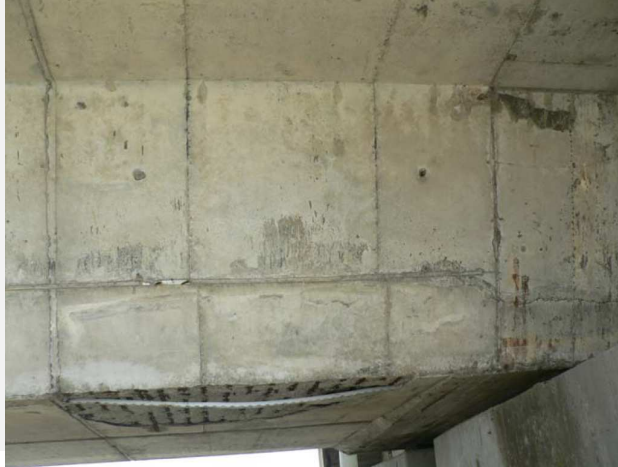
Condition of the bridge: corrosion in bottom, compressed faces

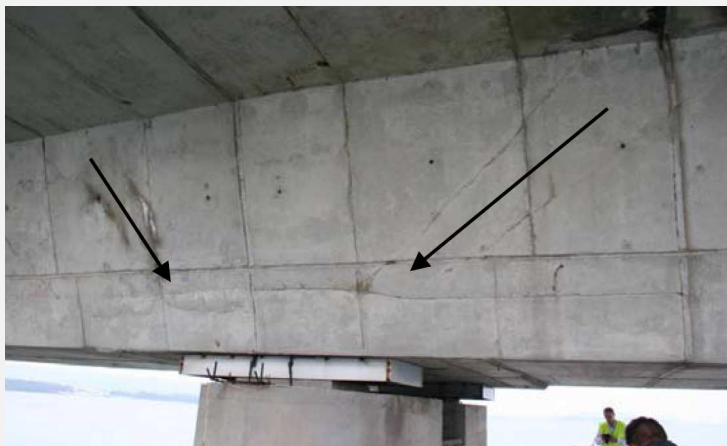
Condition of the bridge: 0.4 mm shear crack width, but no corrosion

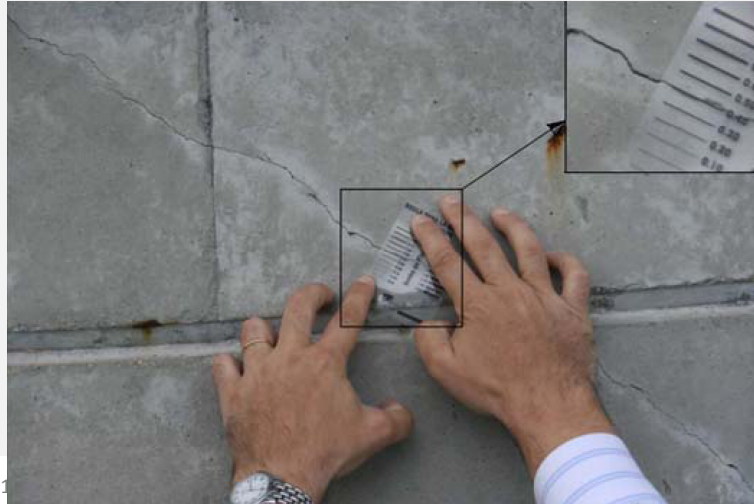
Condition of the bridge: 0.4 mm shear crack width, but no corrosion

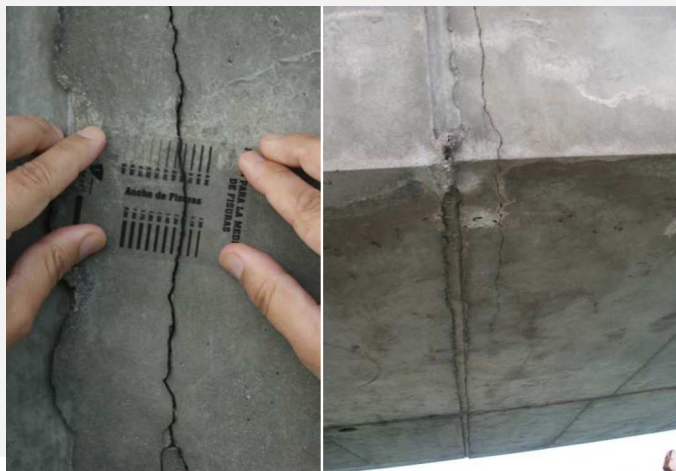
Condition of the bridge: 1.2 mm crack width (couplers), but no corrosion

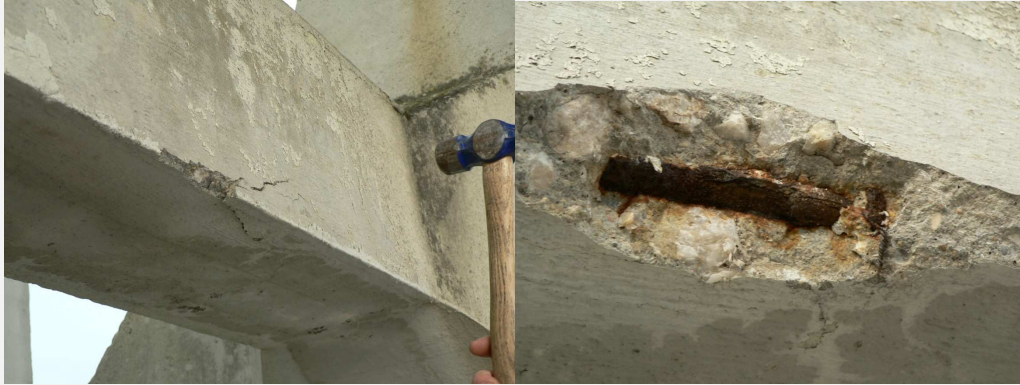
Carbonation induced corrosion in sea exposure condition

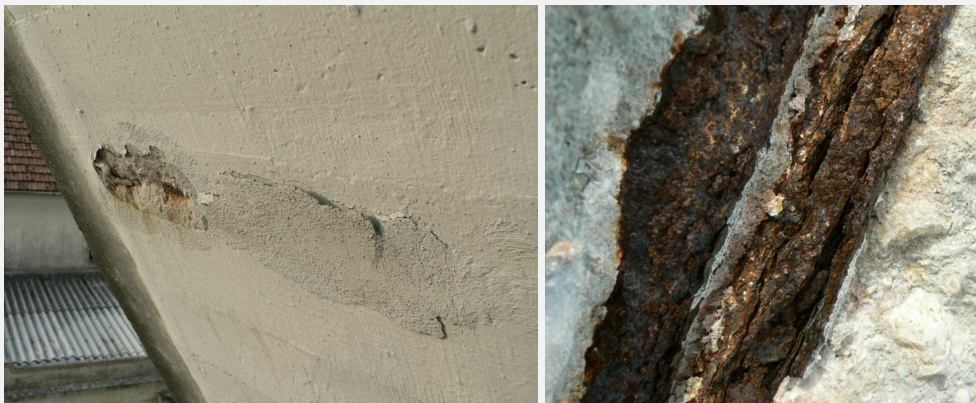
Previously repaired zones

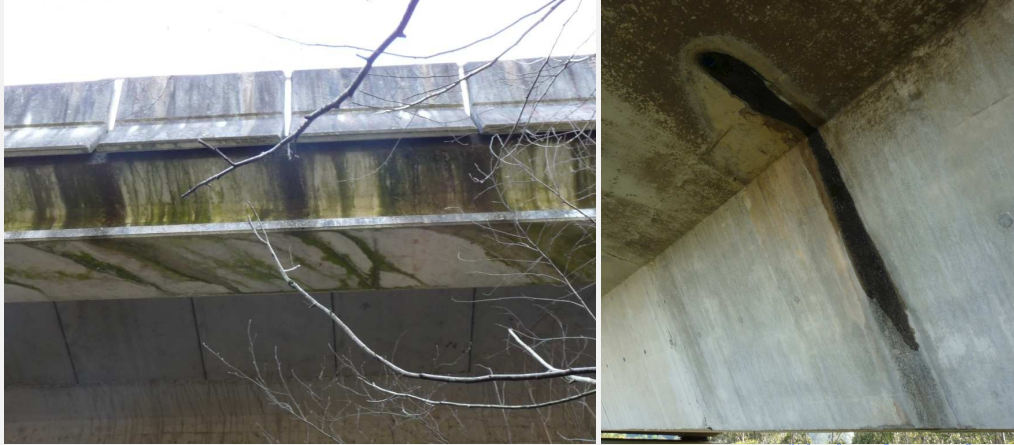
Lack of drainage together with weak railing

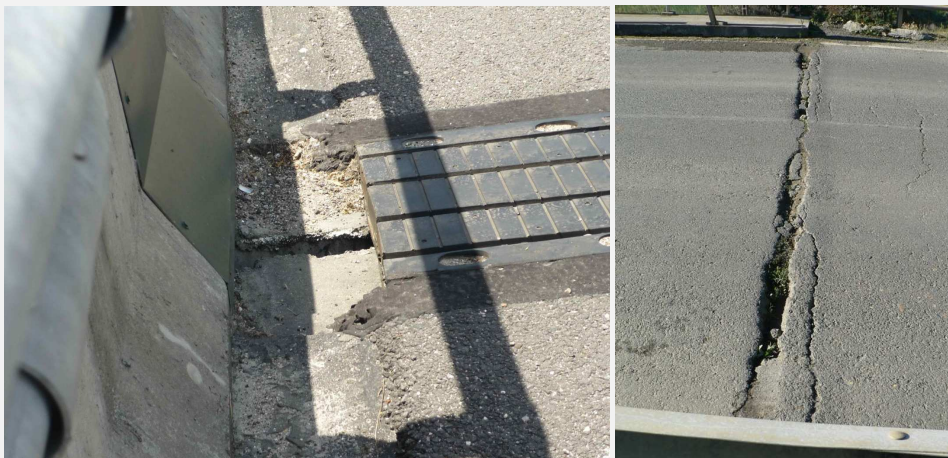
Incomplete or damaged joints: leaking water

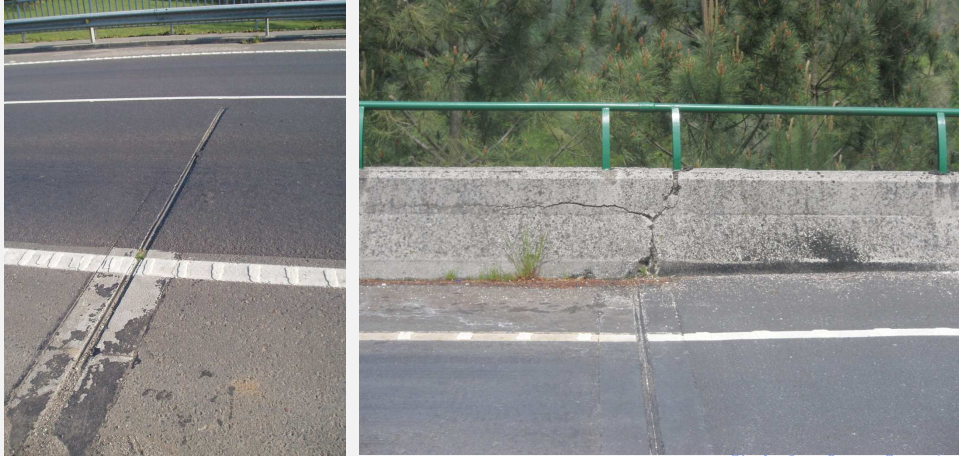
Nonsense, incongruent solutions

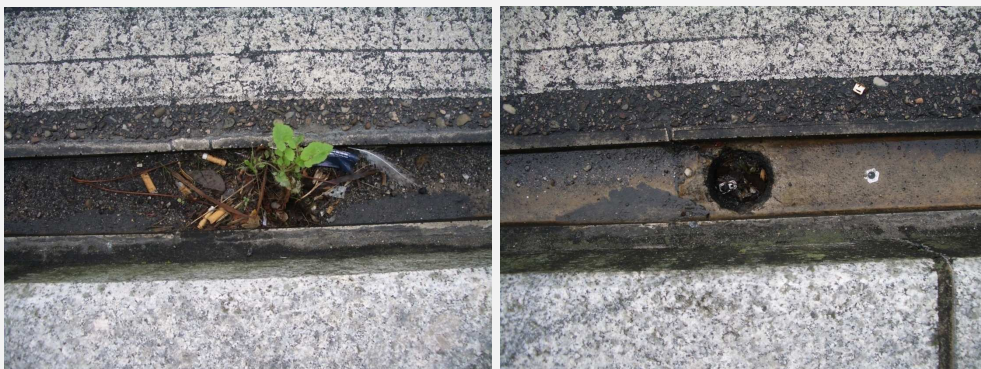
Lack of maintenance

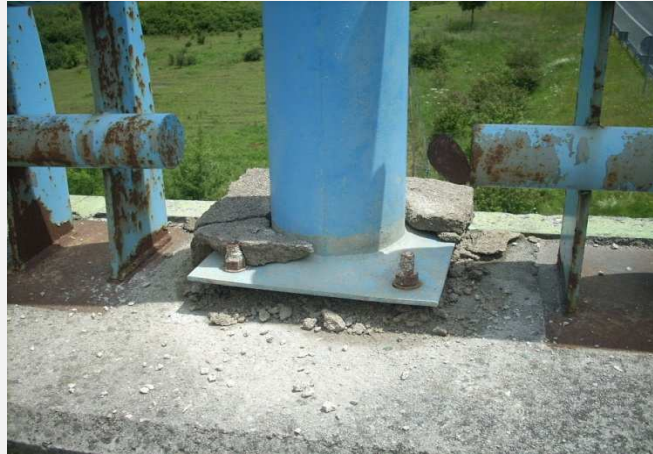
Equipment. A threat to users' safety.
