PERFORMANCE OF CONCRETE BRIDGES IN PORTUGAL

Julio Appleton
A2P Consult, Lda
PhD, Professor IST

The purpose of this paper is to present the author's experience in inspecting, repairing and strengthening relevant 25 to 70 years old concrete bridges and to present a synthesis of the main deterioration problems, structural anomalies and interventions required in these bridges. Recent inspections of the repaired bridges to evaluate the durability of the repair works will also be referred.

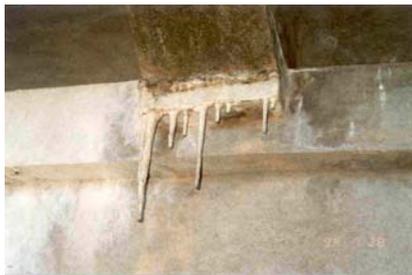
- Significant water penetration through the deck, showing stalactites on the bottom face of the slab (Fig.1 3). When the stalactites were broken, during a dry period, a significant amount of water poured from the deck, showing that the water was retained above and inside the slab (Fig. 1.4).

Fig.1.3. - Effects of the water penetration

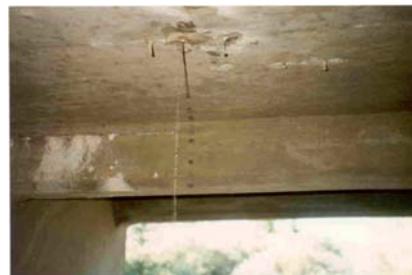
Fig. 1.4 - Water leakage from the slab

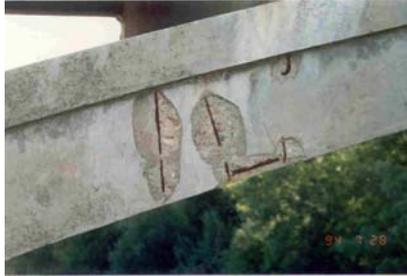
- Localised reinforced corrosion at regions of low cover (Fig.1 5) and concrete segregation due to compacting defects (Fig.1.6)

Fig 1.5 - Local corrosion

The measurements of the reinforcement cover showed large variations: 11 mm to 21 mm in the slab; 6 mm to 13 mm in beams; 0 to 13 mm in arches and 20 to 89 mm in walls.

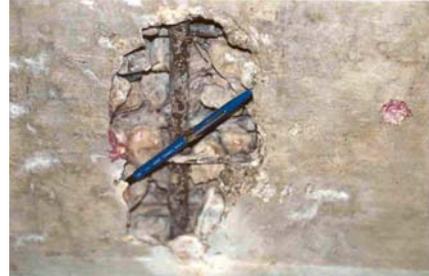
Fig 1.6 - Segregation of concrete

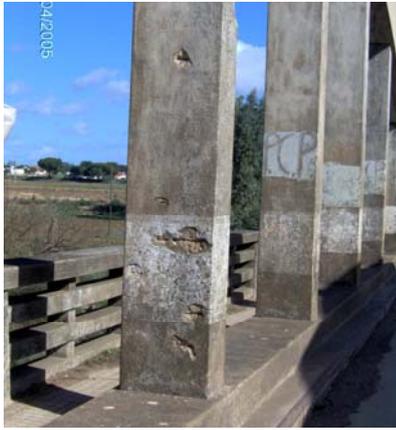
- Local corrosion of reinforcement in the arches, ties and barriers (Fig. 2.3) and slight corrosion of steel bearings (Fig. 2.4).

Fig 2.3 - Local reinforcement corrosion

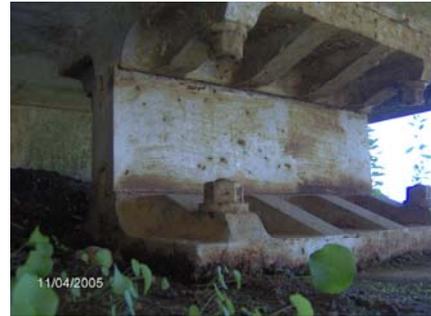
Fig 2.4 - Bearings at the abutments

This intervention requires the replacement of the present steel bearings by high dissipation rubber bearings HDRBs, to introduce axial continuity of both arches and to introduce a light reinforcement of the foundation of the central pier with new micro-piles. This intervention also requires to provide space between the deck and the abutment and to replace the expansion joints.

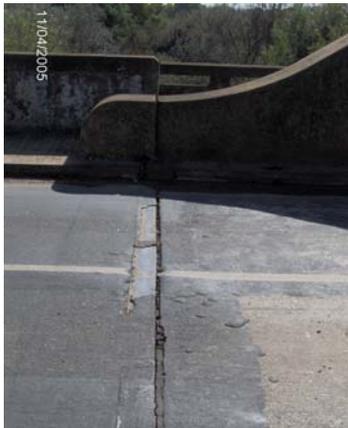
- Deterioration of the expansion joints and surface pavement (Fig 2.5) and local concrete removal due to impact of vehicle (Fig 2.6).

Fig 2.5 - View of the expansion joints

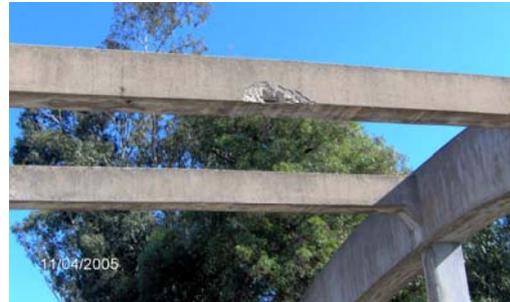
Fig 2.6 - Vehicle impact in a transverse beam

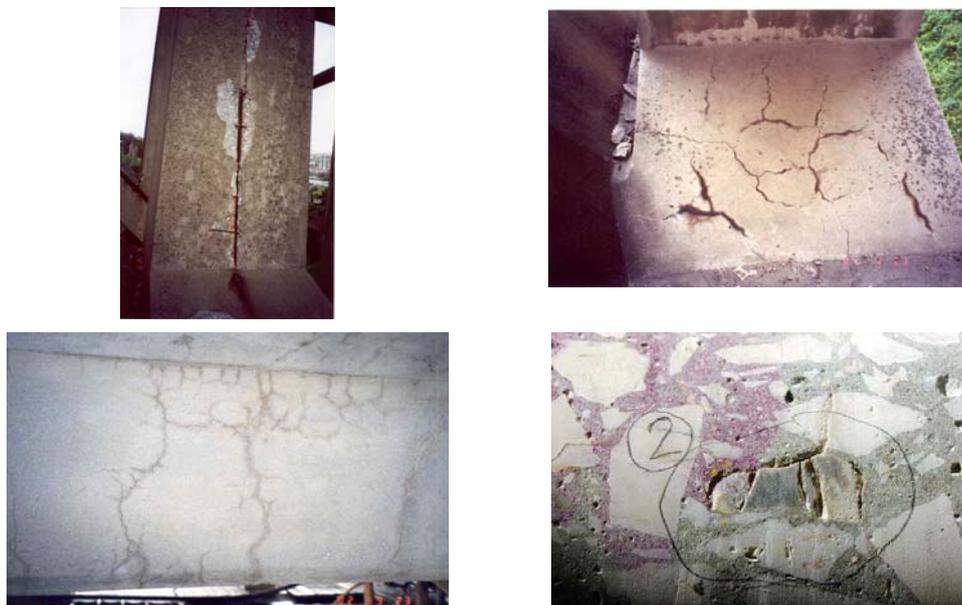
The visual inspection showed the occurrence of irregular cracking ("craquelet") in the structure, Fig. 3.2, vertical cracking in piers and longitudinal cracks in the arches. The cause of this cracking, typically associated with alkali-silica reaction was confirmed through tests with the electronic microscope (MEV) and mineralogic analysis by DRX. The residual potential for the progression of those reactions was assessed to be very little. The origins were coarse reactive aggregates in the form of siliceous and quartz used in the concrete mix.

The cracking due to ASR originate an expansion of the deck, closing the expansion joints and damaging the region of beam supports and the top of the main piers

Fig. 3.2 - Main anomalies

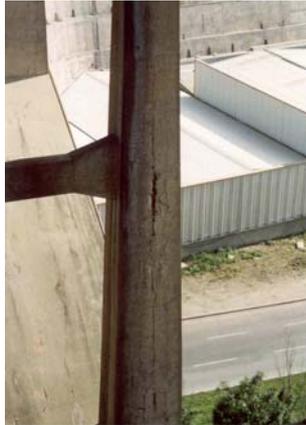
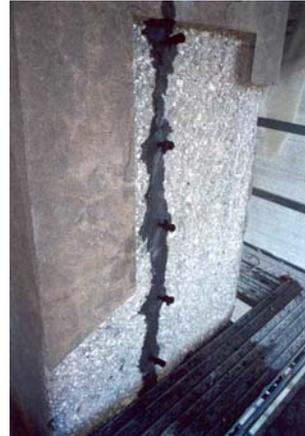
Fig.3.3 - Crack injection in columns

- Local repairing of damaged areas due to reinforcement corrosion.
- Crack injection of large cracks ($\approx 0,50$ mm) with cement grout (Fig. 3.3).

In this figure it can be seen that the main structure was protected with a finish mortar. When required this finish mortar was repaired and completed with a cement mortar added with latex.

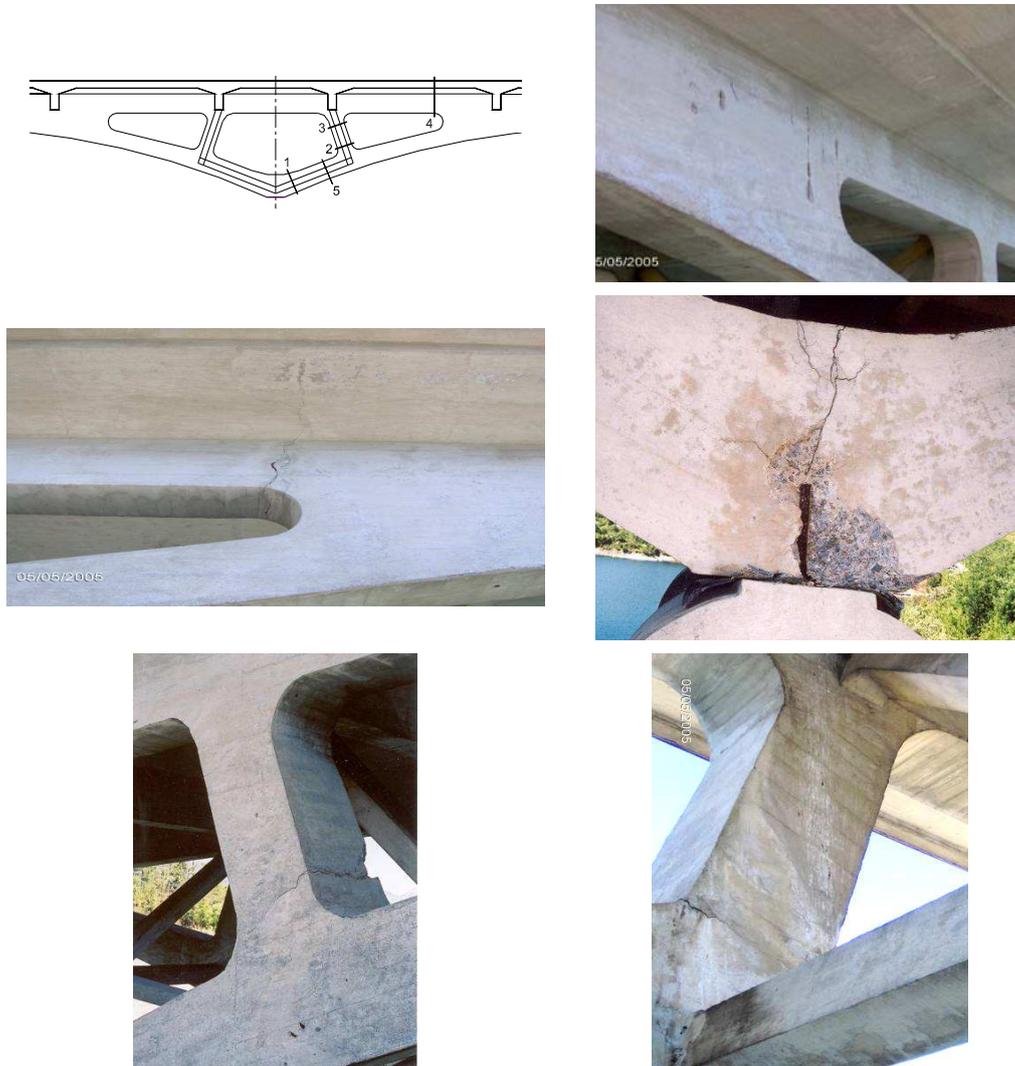
- The main girders are systematically cracked in all spans at 5 main sections, as represented in Fig. 4.2
- Some local delamination occurs in regions of low cover. The cover presents a large scatter varying from 5 mm to 98 mm and the carbonation depth varies from 3mm to 47mm. Concrete has a good quality; its strength obtained in cores varies from 36 MPa to 58 MPa.

Fig 4.2 - Main structure cracking in the girder deck

A 3D linear elastic model and a nonlinear analysis (Athena software) showed that, for the permanent loads, cracking in the referred 5 sections was to be expected (Fig. 4.3). The extent of the cracking was due to a misjudgement of local effects in the structure. Safety requirements were not also guarantee, thus a strengthening intervention was required.

An external prestressing was introduced at the top flange girder, with 2 x 7 strands per girder (Fig. 4.4). This is an active strengthening technique that presents several advantages. The ultimate capacity assessed with the nonlinear model increased from 1,35 PL + 0,5 LL to 1,35 PL + 2,0 LL. Together with this main intervention the general rehabilitation of the bridge is under progress.

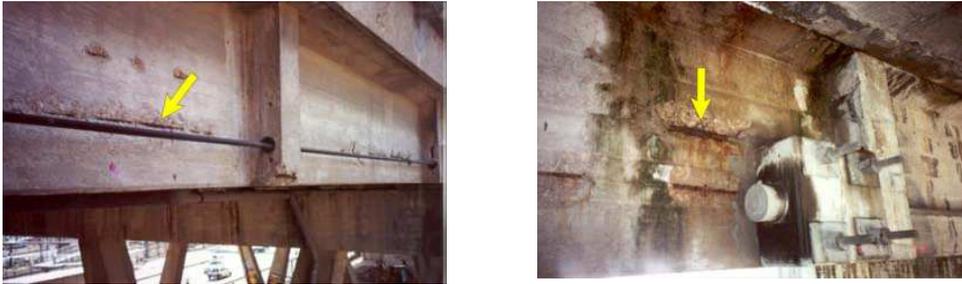
- Local reinforcement corrosion, mainly in the external beams and in low cover regions
It is to be referred that the web reinforcement was placed outside the stirrups leading to horizontal cracking and corrosion of these horizontal bars (Fig. 5.2).

Fig 5.2 - Horizontal web reinforcement exposed due to corrosion

The rehabilitation works included the local repairing of all damages, a new concrete surface protection and the waterproofing of the deck central region where main leakage occurs.

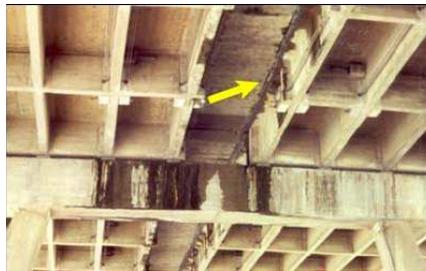
- Countless water penetrations from the deck creating deterioration areas under the deck (Fig. 5.3)

Fig 5.3 - Water penetration from the deck

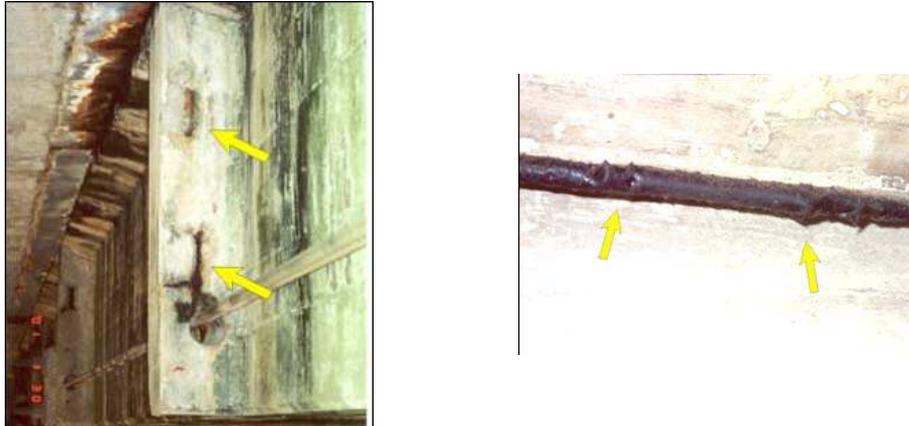
- Deterioration of the anchorages and of the mono-strand plastic ducts of the external prestressing system (Fig. 5.4).
- Damages in concrete blocks serving as girders bearings.
- Deterioration of expansion joints

Fig. 5.4 - Damages in concrete anchorage regions and in the plastic duct of the mono-strands

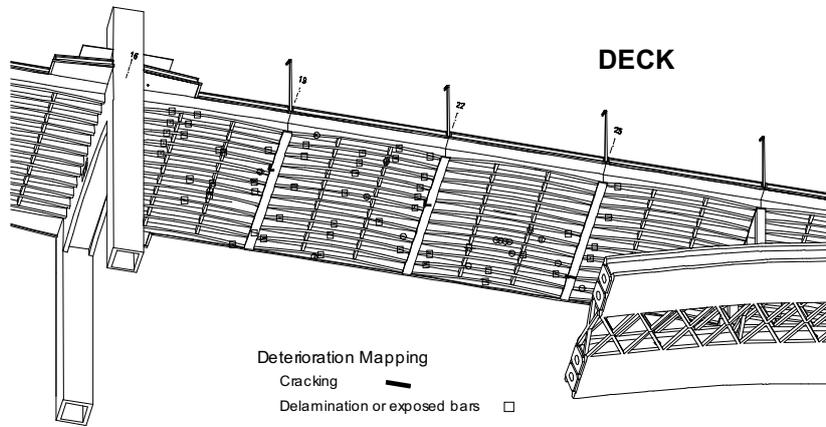
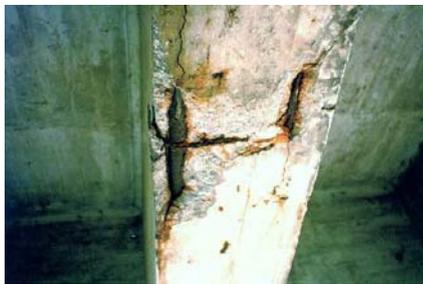
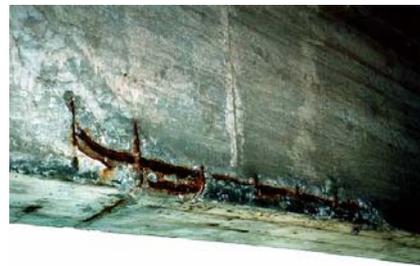
One main observation was the extensive delamination, spalling and reinforcement exposure in many beams over the arch, mainly concentrated in the soft corners or near construction joints. Other areas with low cover or concrete defects showed significant corrosion of the reinforcement. The surface paint almost disappeared over the river, the most exposed surfaces of the bridge.

Exposed bars in construction joints and low cover regions

Fig. 6.2 - Visual inspection. Main pathologies

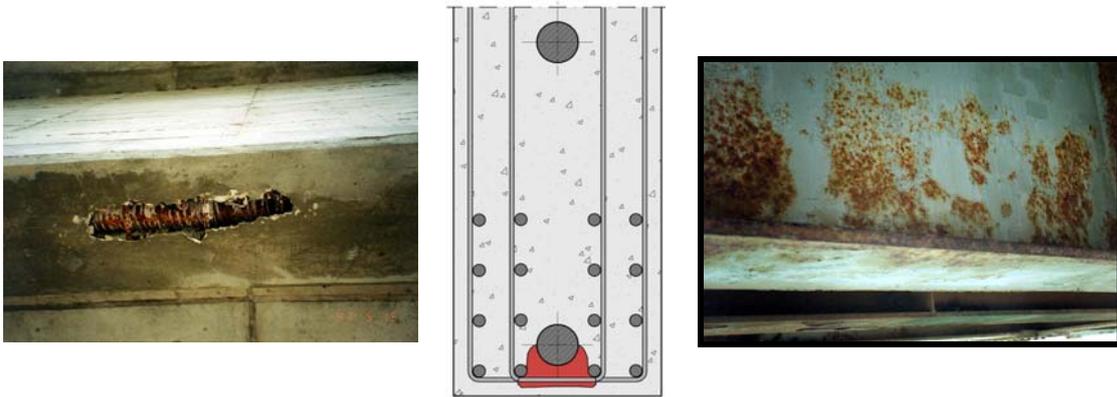
- The quality of execution was low. Concreting defects such as voids in prestressed concrete beams and low reinforcement cover were frequent. The painting of the steel structures was also of poor quality (Fig 7.4).

Fig 7.4 - Concrete defects in prestressed girders and corrosion in main steel beams of the cable stayed bridge
