Bridge Inspection and Repair

National Roads Authority, Ireland

Duratinet 2010 Ireland

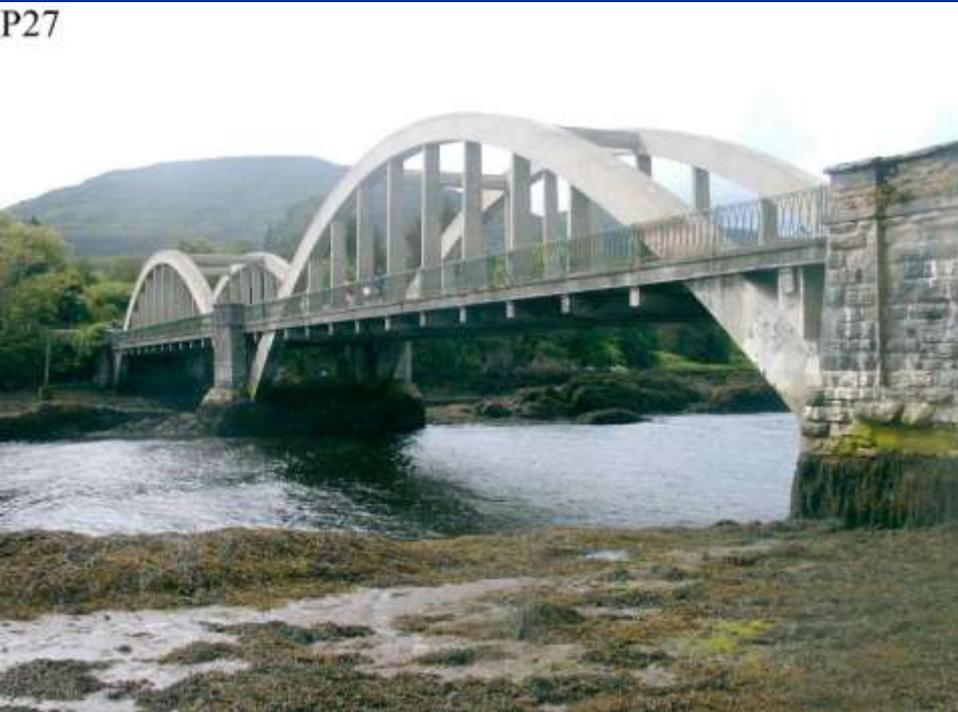
P27

RC Bridge Defects

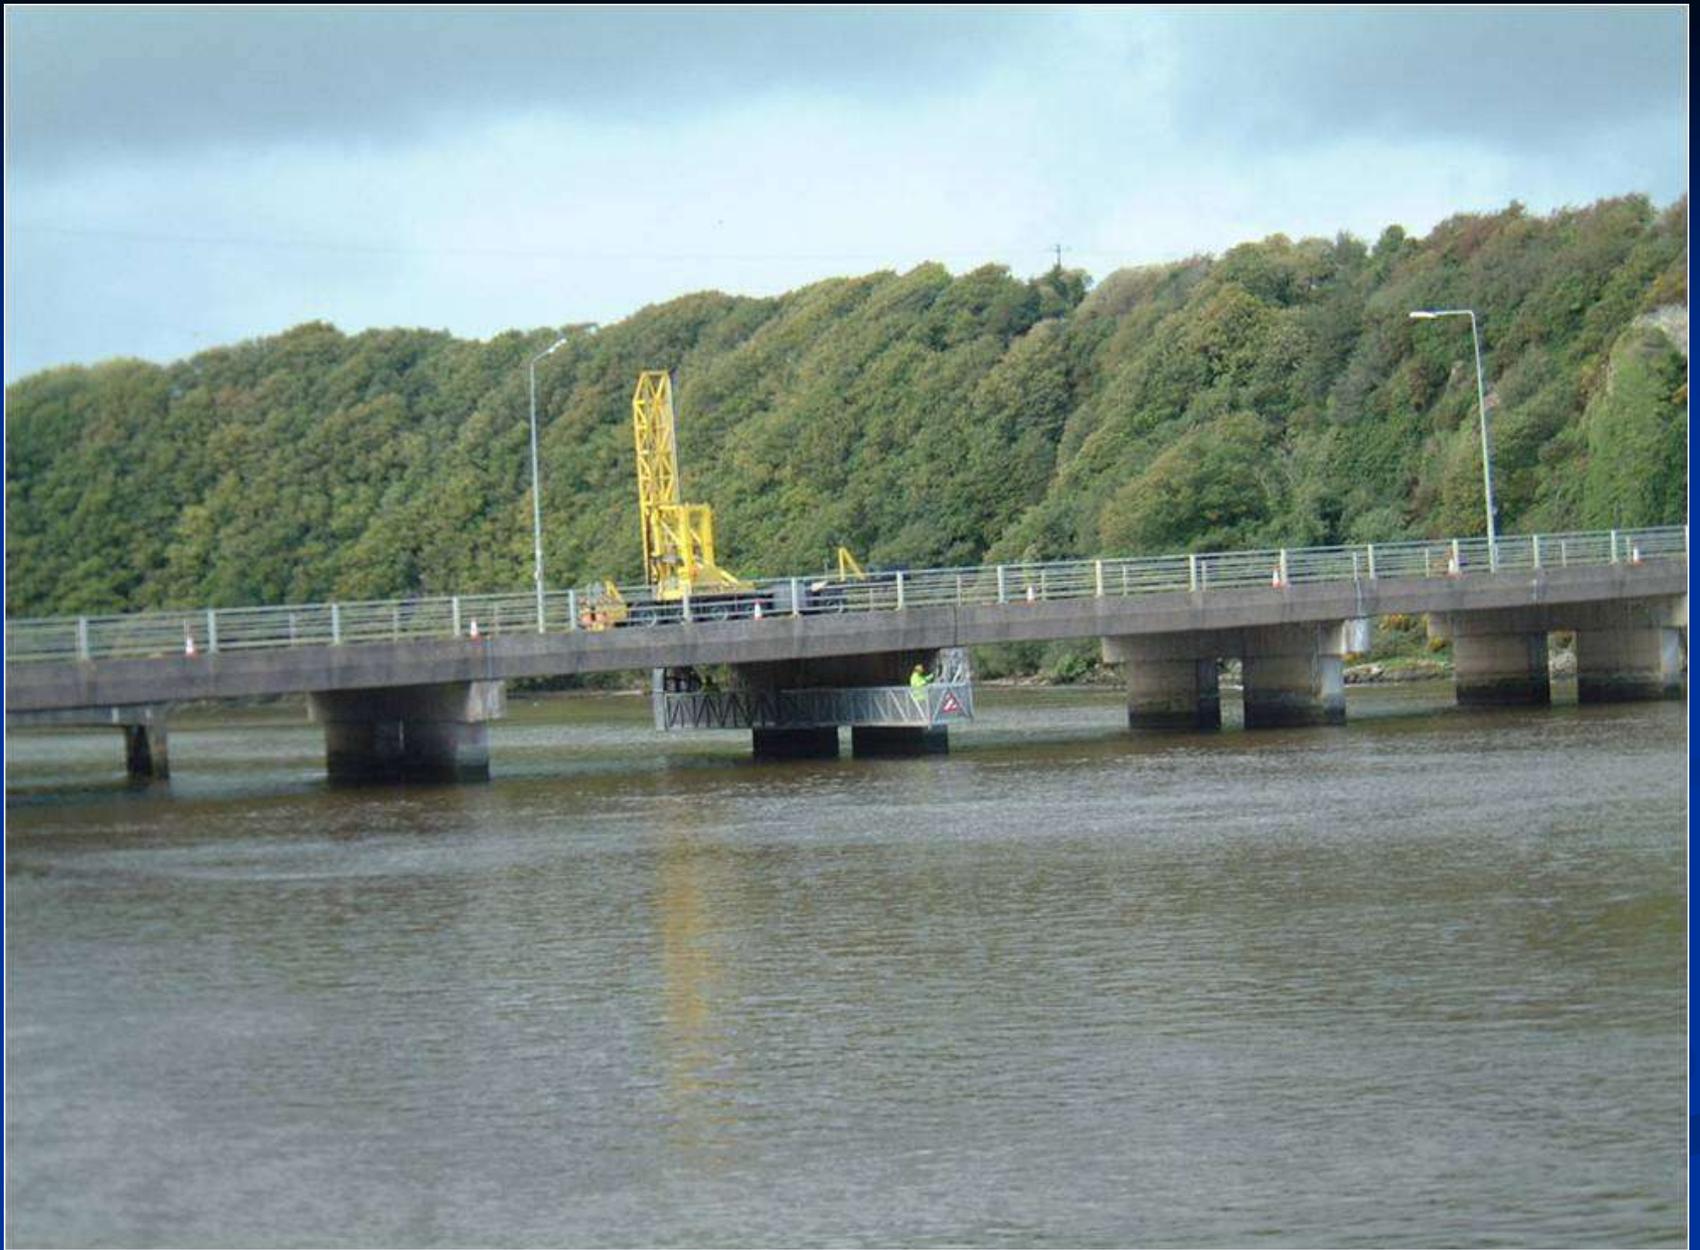
- 8 span bridge on RC piers
- Cracks up to 1.5mm wide in crossheads
- Insufficient reinforcement in crossheads
- Crossheads strengthened with additional rebar
- Research opportunity – different types of concrete repair for each crosshead
- Remote monitoring of structural health

- Pier crosshead strengthening
- Crosshead concrete repairs:
 - Standard OPC mix
 - OPC mix + increased cover
 - OPC mix + silane
 - OPC mix + mixed-in corrosion inhibitors
 - Ground Granulated Blastfurnace Slag mix
- Remote monitoring of
 - Rate of chloride penetration
 - Rate of corrosion if initiation occurs

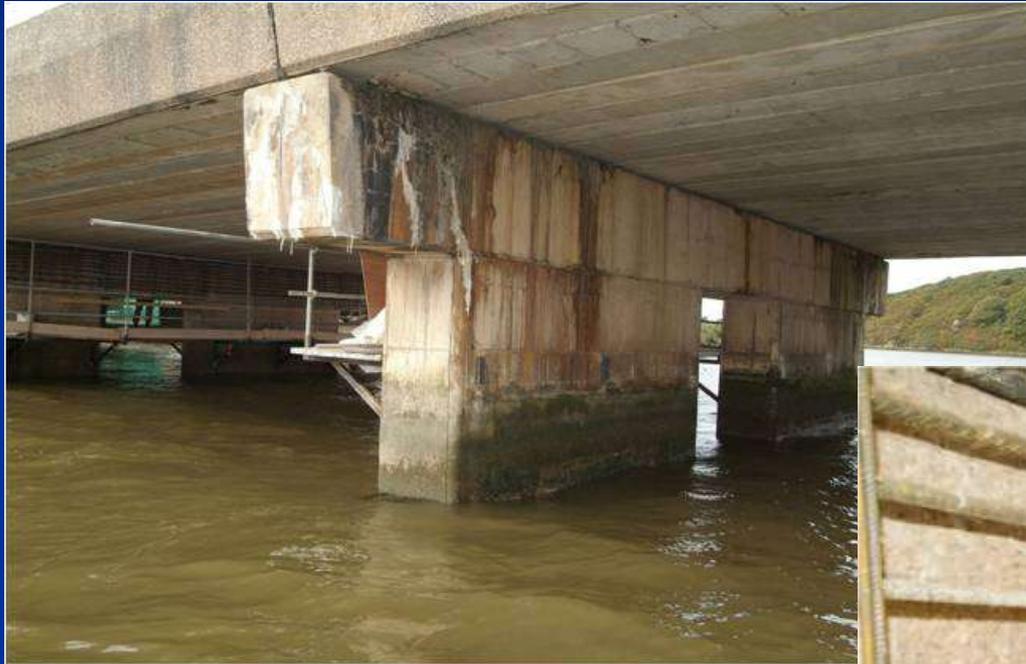
DSCF9861

Ferrycarrig Bridge
