PERFORMANCE OF CONCRETE BRIDGES IN PORTUGAL

Julio Appleton
A2P Consult, Lda
PhD, Professor IST

The purpose of this paper is to present the author's experience in inspecting, repairing and strengthening relevant 25 to 70 years old concrete bridges and to present a synthesis of the main deterioration problems, structural anomalies and interventions required in these bridges. Recent inspections of the repaired bridges to evaluate the durability of the repair works will also be referred.

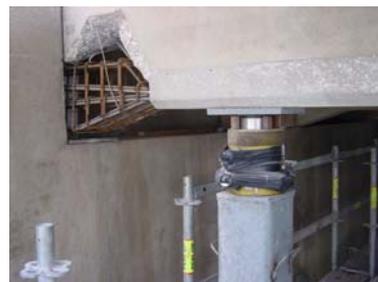
Fig 3.8 - Reconstruction of girder support region

- Reconstruction of the slabs of the cantilevers, which had significant deterioration and a slab thickness of 7 cm. They were replaced by a new 10 cm slab (Fig. 3.7). Damaged support regions of the girders were also reconstructed (Fig. 3.8) as well as the top of the main piers.

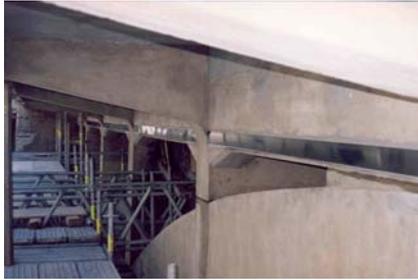
Fig 3.9 - Strengthening of lateral girders with CFRP laminates

The safety assessment of the deck showed that, after enlargement of the road, the lateral girders (originally under a pedestrian path) had not enough reinforcement. They were strengthened with CFRP laminates located in the lower region of the webs (Fig. 3.9).

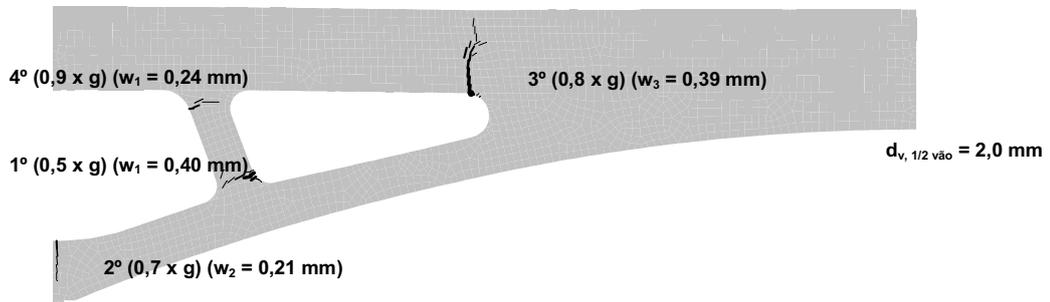
Fig. 4.3 - Non linear analysis. Cracking

A 3D linear elastic model and a nonlinear analysis (Athena software) showed that, for the permanent loads, cracking in the referred 5 sections was to be expected (Fig. 4.3). The extent of the cracking was due to a misjudgement of local effects in the structure. Safety requirements were not also guarantee, thus a strengthening intervention was required.

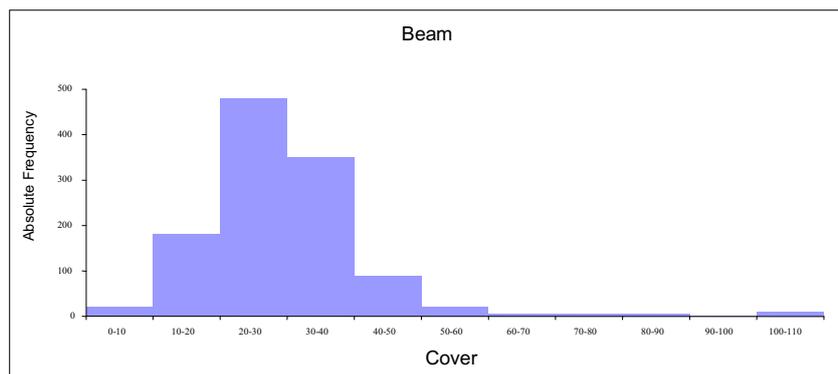
Fig. 6.3 - Variation of cover in the main girders

The variability of the concrete properties, cover and penetration processes are very important to access the deterioration process. Figure 6.3 shows the variability of the cover measurements in the main girders of Arrabida Bridge.

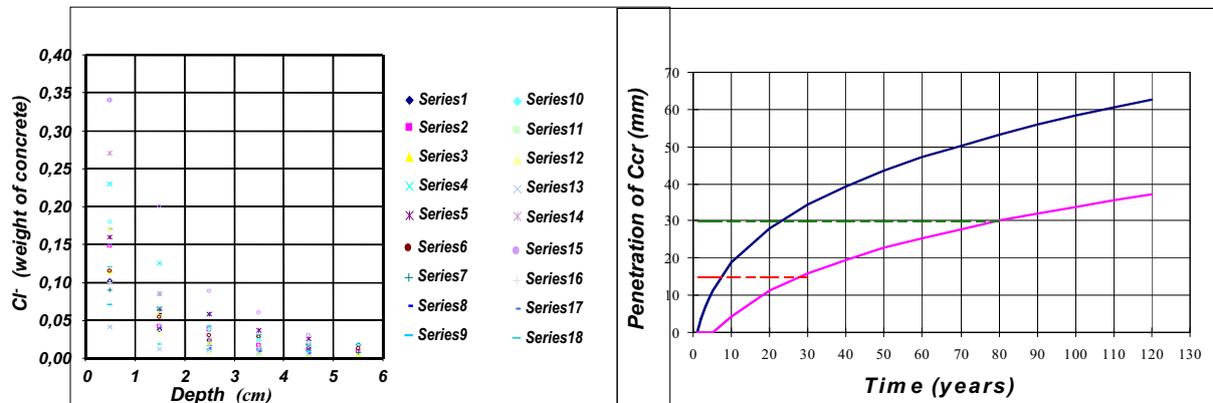
Fig. 6.4a - Chloride penetration near construction joints in the girders

The assessment of the chloride penetration is illustrated in Fig. 6.4, where the chloride concentration at different levels is presented. These results were obtained after 35 years of service and from samples taken in the construction joints, the location where deterioration is more relevant. It is also important to stress the fact that these results will vary from element to element due to the heterogeneity of concrete, eventual use of different mixes, different compaction and curing, different exposure conditions, ...

From these results and assuming a diffusion of chlorides governed by the modified Fick's law and considering the variation in time of the diffusion parameters it is possible to obtain an interpretation of the penetration process and a prediction of its evolution. In Fig.6.4b the relation between the time needed for the chloride content to achieve a level of 0.05 % by weight of concrete is presented. The envelope between the two curves reflects the variability of the critical chloride penetration.

From these curves it is possible to understand that for the average cover depth in the girders of 27 mm the time needed for the critical chloride content to be reached at this level varies between 20 and 70 years. Then depassivation occurs, corrosion may start and the corrosion rate variation can be assessed.

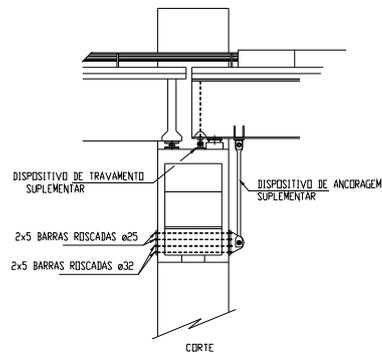
Fig. 7.9 - Replacing and strengthening the anchorage system of the deck to the transition piers

- Replacement and strengthening of the anchorage system of the deck to the transition piers. The initial conceptual design led to the transfer of tension forces from the deck to the transition pier which was guaranteed by prestressing bars. This system was duplicated in this intervention (Fig. 7.9);

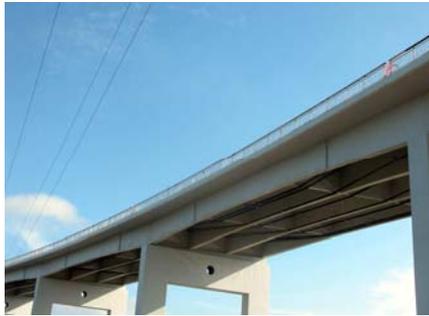
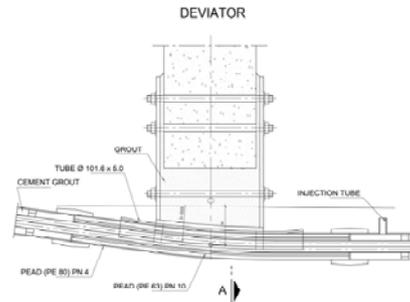
Fig. 7.10 - External prestressing of the approach viaducts and details

For the approach viaducts the strengthening of the main girders by external prestressing was also introduced (Fig. 7.10). This work was required due to the fact that the live load adopted in the design were lower than the recent code values as well as to the damages observed in the beams (cracking, concrete defects).
